Manhole Inspection Summary

Manhole # S37G__046MH

Insp Date: **8/18/08 11:44 AM**

Location Address: **500 e baltimore st**

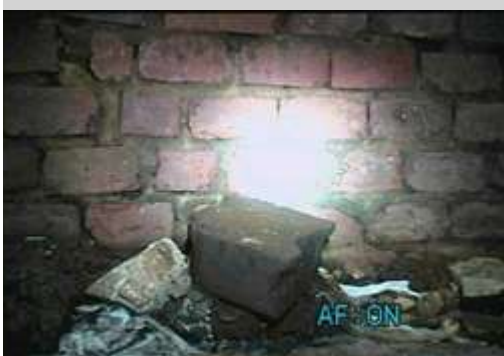
Misc

Condition: ☒ Sound ☐ Cracked ☐ Root Intrusion ☐ Deteriorated ☐ Leaks ☐ Debris

bench debris

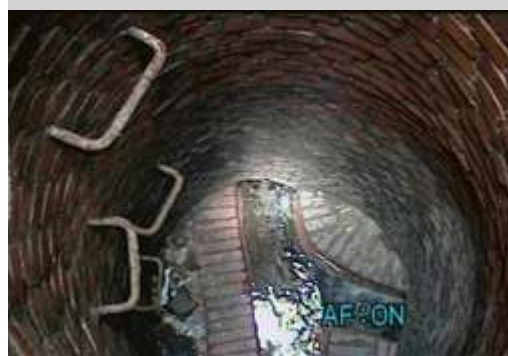
Defect 2

Condition: ☐ Sound ☐ Cracked ☐ Root Intrusion ☐ Deteriorated ☐ Leaks ☒ **Debris**

channel debris

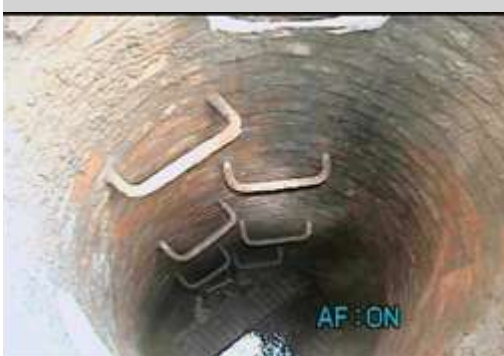
Defect 1

Infiltration: ☐ None ☒ **Joint** ☐ Cracks ☐ Mortar ☐ Roots ☐ Wall

Count: **8** Missing: **0** ☒ **Corroded**

corroded steps, chimney infiltration evidence

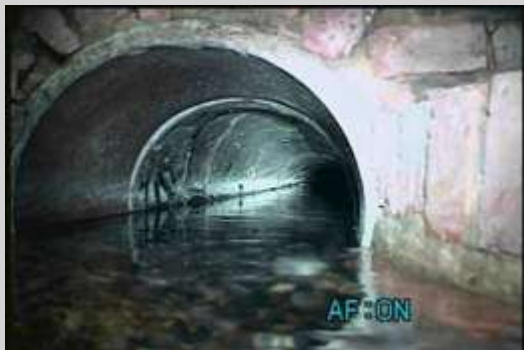
12 O'Clock Outflow

12 in. Circular Gravity Sewer
Pipe Out @ 12 O'Clock

Deposits: ☒ None ☐ Mud ☐ Sludge ☐ Debris ☐ Grease

Infiltration: **None** Pipe Seal Cond: **Unknown**

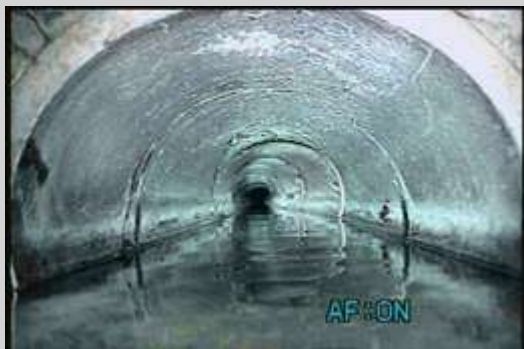
3 O'Clock Inflow

10 in. Circular Gravity Sewer
Pipe In @ 3 O'Clock

Deposits: ☒ None ☐ Mud ☐ Sludge ☐ Debris ☐ Grease

Infiltration: **None** Pipe Seal Cond: **Unknown**

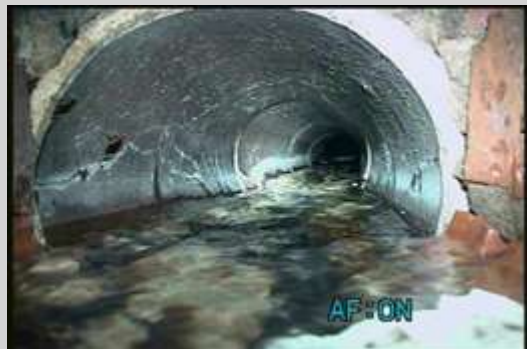
6 O'Clock Inflow

10 in. Circular Gravity Sewer
Pipe In @ 6 O'Clock

Deposits: ☒ None ☐ Mud ☐ Sludge ☐ Debris ☐ Grease

Infiltration: **None** Pipe Seal Cond: **Unknown**
